### Assessment of Potential Archaeological Collections Facility Sites at Eaker Air Force Base, Blytheville, Arkansas

Archaeological Curation-Needs Assessment Architectural-Archaeological Report No. 2

U.S. Army Corps of Engineers St. Louis District

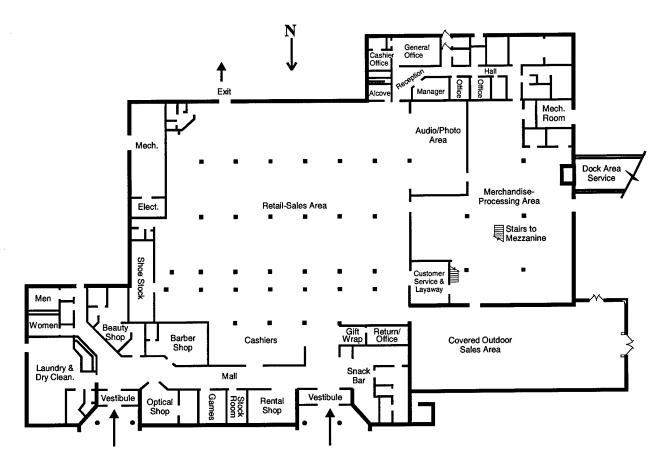
Figure 5. Floor plan of Building No. 552 (not to scale).

Base Exchange Building No. 552 (Figure 4) was constructed in 1956 and renovated in 1987; it encompasses 32,925 ft<sup>2</sup> (Figure 5). The initial space needed for the proposed MVCHC is 22,866 ft<sup>2</sup>, with a potential for future expansion up to 39,880 ft<sup>2</sup>. The expansion needs are for additional artifact-storage space; this will

presumably become necessary within approximately 10 years. The initial need for 22,866 ft<sup>2</sup> can be met immediately, with 10,069 ft<sup>2</sup> unoccupied until a later time when the space will be needed. When the total of 39,880 ft<sup>2</sup> is needed, the storage area can be remodeled into a two-level plan. This will double the amount of storage space.

Many of the spaces within the existing building were constructed for uses similar to that needed for the proposed MVCHC. For example, the building has a loading dock, dock leveler, and receiving area, which could be used with no alteration for the MVCHC. In general, only minor structural modifications would be necessary to adapt the building to the proposed use. The majority of space in the existing building is single story; however, a portion of the building is a two-story space currently occupied with a steel mezzanine and two levels of storage (Figure 6). Medium-duty steel shelving remains from the building's previous use as the base exchange. Existing shelving would suffice for lightweight objects, but heavy-duty shelving units would be necessary to support the weight of lithic collections. The current square footage could be doubled by utilizing the mezzanine concept for storage when additional storage space is needed.

Base Exchange Building No. 552 is recommended as one of two potential buildings at Eaker AFB that could be rehabilitated for use by the AAS as the MVCHC.

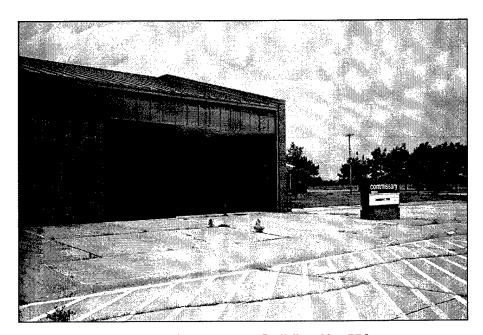
Figure 8. Commissary Building No. 556.

Constructed in 1959, and first renovated in 1973, this building (Figure 8) encompasses 38,575 ft<sup>2</sup>. The superstructure is a steel frame, and the exterior is a combination of exterior insulation and finish (EIFS) and steel siding. The main entrance has a pleasant appearance and is consistent with a public, commercial building. Some existing areas within the building are similar to those needed for the proposed MVCHC. For example, the existing refrigeration rooms and food-processing areas could be modified to serve as specialized storage, cleaning, and processing areas, respectively. Although similar in function, the existing areas are much too large for

the proposed cultural heritage center; a significant initial cost to the user would be required to renovate these areas.

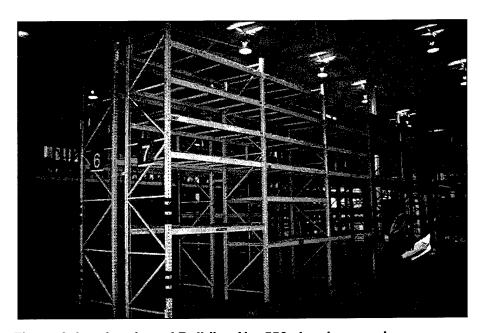
Figure 9. Interior view of Building No. 556 showing warehouse space.

The existing warehouse space is three-stories high (32 feet high), encompasses approximately 10,000 ft², and contains many heavy-duty storage racks. The storage racks (Figure 9) are approximately 20 feet high and must be accessed by mechanical lifting devices. This storage environment was used for bulk items such as furniture or large boxes; it is doubtful that this large space could be put to a productive use without significant alterations and additions of intermediate floor levels. This building is not considered to be a reasonable choice for use by the AAS as the MVCHC.

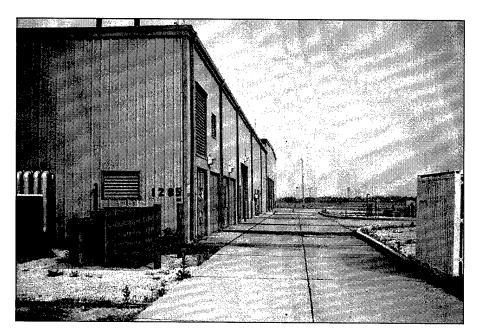
Figure 10. Missile Assembly Building No. 1285.

This is a reinforced-concrete building with exterior, metal siding (Figure 10). The building was constructed in 1985; it encompasses 32,336 ft<sup>2</sup>, of which approximately 28,104 ft<sup>2</sup> is ideal for industrial or manufacturing uses (Figure 11). The

remaining 4,232 ft<sup>2</sup> is best utilized as office space. A very substantial building in good condition, it has a continuous overhead crane rail that connects all of the industrial rooms (Figure 12). The industrial areas are accessed through 12-x-20-foot swinging doors.

The Blytheville-Gosnell Regional Airport Authority is of the opinion that the best use of this building will include some type of manufacturing function. After inspecting the building, we agree with this conclusion and find that the building would be underutilized as a cultural heritage center. This building is not recommended for use by the AAS as the MVCHC.

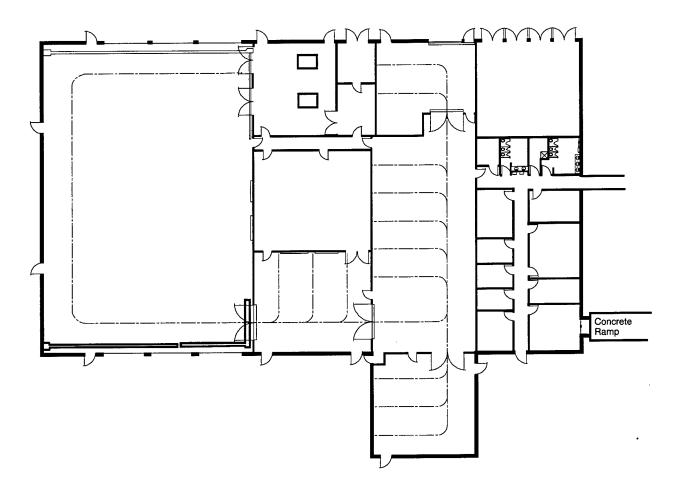
Figure 11. Floor plan of Building No. 1285 (not to scale).

The industrial nature of this building makes it ideal for heavy manufacturing or assembly. One can visualize large industrial parts being attached to the overhead crane and carried to and through various rooms for assembly, painting, or finishing.

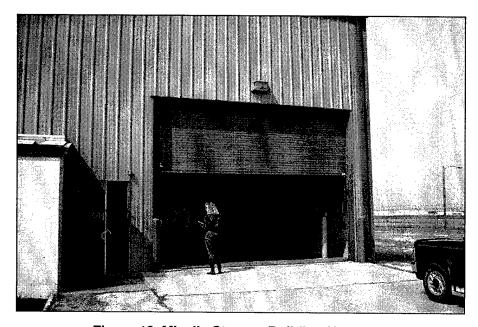
Figure 13. Missile Storage Building No. 1286.

Constructed in 1985, this preengineered, metal building is in very good condition and encompasses 8,951 ft<sup>2</sup>. The building has a heavily reinforced concrete floor that can support substantial loads. Overhead, rolling doors allow vehicle access into and through the building (Figure 13). The interior height from the floor to the bottom of the roof structural members is 31 feet; the building could be divided vertically with an additional floor. Because the building was originally used for storage, it has an unfinished interior. As a result, the entire structural system is exposed to view and uncluttered. These characteristics make the building ideal for future development, because there is very little to modify in the building, and construction could easily begin without

first removing existing finishes or unusable systems. Unfortunately, the program requirements for the MVCHC call for an initial area of 22,900 ft<sup>2</sup>. Building No. 1286 is thus too small, even if a second floor was added. This building is not recommended for further consideration by the AAS as the MVCHC.

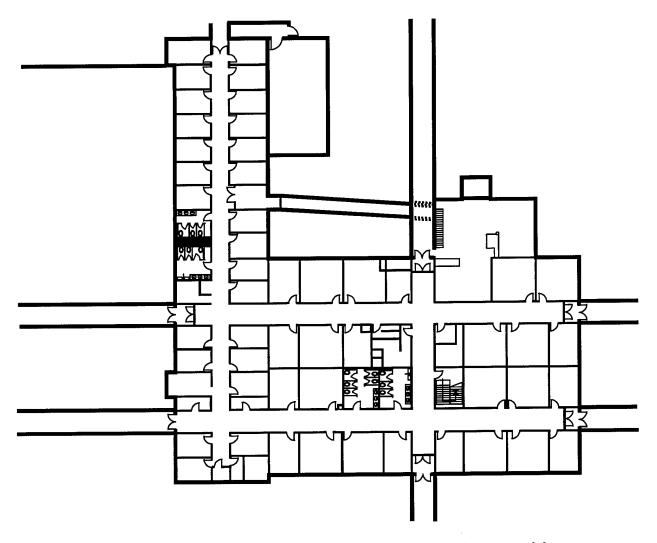
Figure 14. Floor plan of Building No. 1225, lower level (not to scale).

This building was constructed in 1960, and an addition was built in either 1985 or 1986. This is a two-story building that encompasses 28,891 ft<sup>2</sup>. The building is different from the other buildings discussed in this report because the first floor (which is at natural ground level) is earth-sheltered. An earthen berm extends from the natural ground level to just below the second-floor level. The lower level was formerly used as sleeping quarters for pilots and is partitioned into individual sleeping rooms (Figure 14). The upper level contains cooking and dining areas, recreational spaces, a meeting room with an audiovisual projection area, and offices (Figure 15).

Additionally, the lower level is partitioned off into many separate rooms. This would allow ample space for collections storage, and individual collections could be stored intact. This would likely be viewed as an attractive feature to curators.

The disadvantage of using this building as the MVCHC is that none of the existing entrances is well suited for a public facility. To enter the building at ground level and at the lower level, one must walk through a tunnel walkway. To access the upper level from ground level, one must walk up a long ramp. Neither of these means of access is desirable for public use.

To remedy this, it is proposed to create a public entrance at the lower level with means to transport people to the upper level immediately after they enter the building. This would be accomplished by removing a portion of the earthen berm and replacing it with an entrance plaza, constructing an appropriate lobby, and

installing an elevator. These solutions would resolve the need for an appropriate public and handicapped-accessible entrance while taking advantage of the existing earthen berm for storage at the lower level.
